UOP Adsorbent Solutions in Ethylene Plants

Mitigate online moisture analysers problems and help protect your Plant Reliability

Luk Verhulst, UOP Antwerp/Belgium

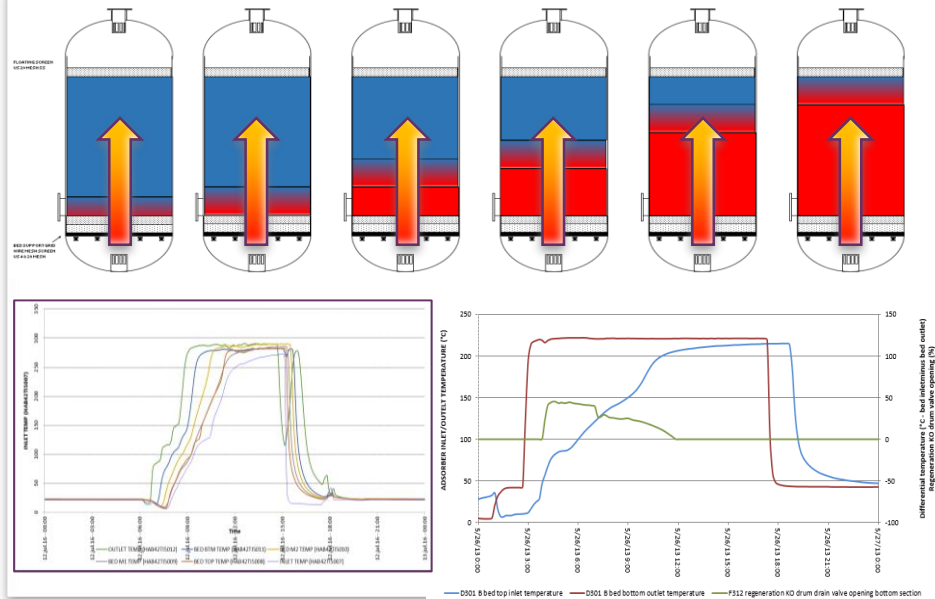
Charge Gas Drying Unit Typical Operation Adsorption Process

- Repetitive continuous cycling of adsorption & regeneration
- Adsorption dynamics & equilibrium in every cycle
- Regeneration dynamics & desorption efficiency in every cycle

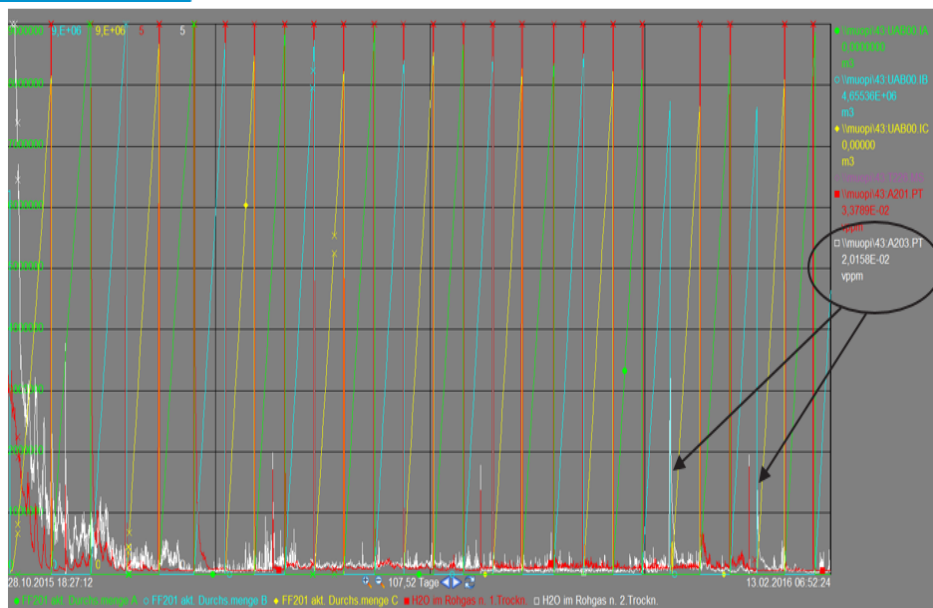
UOP Case Study 1

- 3-bed dehydration unit
- Excellent operation for 6 months, one drier losing capacity rapidly
- Response of online analyser at bed probe & bed outlet seems reversed on affected drier
- No operational issues downstream

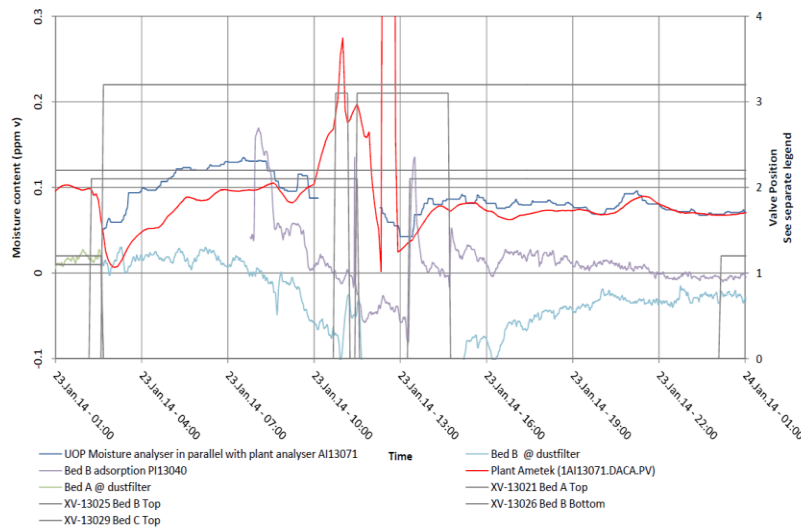
UOP Case Study 2

- 3-bed dehydration unit
- Excellent operation for 6 months on conservative fixed cycles
- Apparent conflicting moisture readings of old & new plant online analyser
- UOP onsite testing also different from new plant analyser
- Drier “slipping moisture” switched back on line for another 18-hour of excellent drying

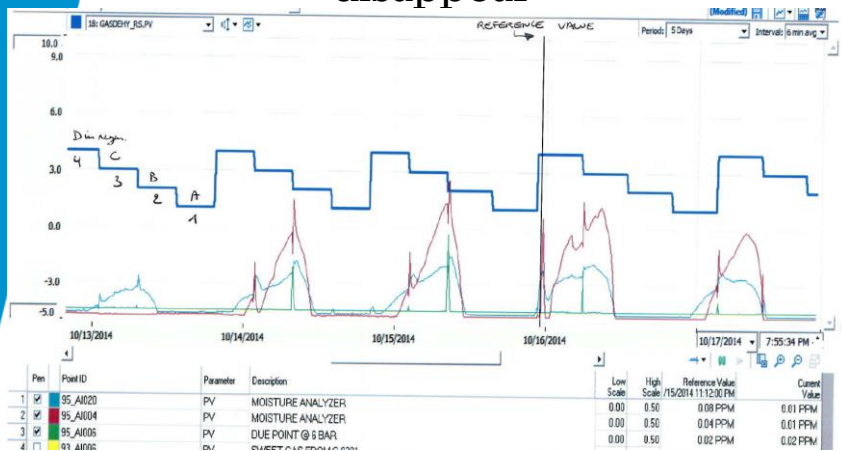
UOP Case Study 4

- 4-bed dehydration unit
- Excellent operation for 2,5 years with no operational issues downstream
- Conflicting response of 3 online analysers at common outlet: apparent moisture slippage from 1 drier shows on 2 analysers

- UOP onsite moisture analytical service confirms excellent drying of all driers
- Cycle extension demonstrates no link with adsorption cycle
- 2 plant analysers checked out and nightly erroneous water peaks disappear
